Good preventive maintenance includes giving your Apache a bath once in a while. But be careful. Too much of a good thing can short out the bottom transponder antenna.

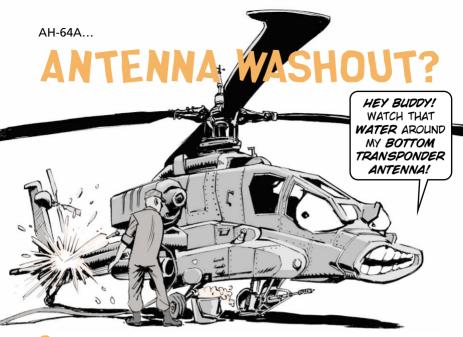
When water gets into the antenna, it shorts out internal electrical components and you'll get a NO-GO light on the transponder control panel during pre-flight checks. A NO-GO light could mean your aircraft isn't ready to identify itself to challenging aircraft and ground facilities.

If water gets into the antenna, your repairman will have to remove the antenna per Para 4-7-7 of TM 11-1520-238–23-1 and empty out the water.

Then you should do another maintenance operation check on the bottom antenna like it says in Para 14-13 of TM 11-1520-238-23-2.
